WAYNE STATE
UNIVERSITY

McGregor Pond Restoration
Detroit, Michigan

SCHEMATIC DESIGN REPORT

March 3, 2011

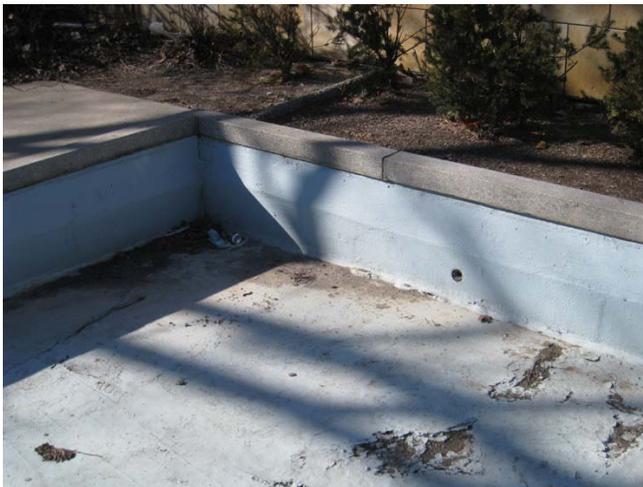
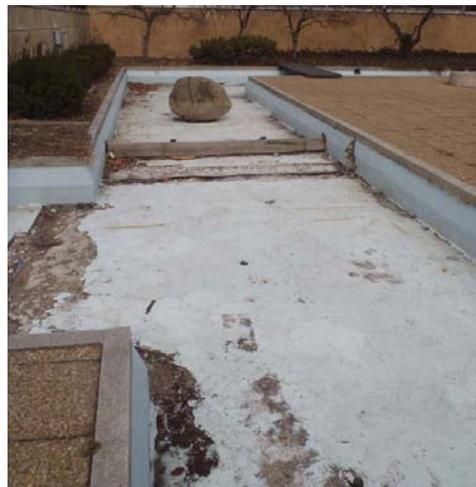
As indicated, the concrete foundation is plagued with severe cracking and spalling, leading to water infiltration within the structure and the inability of the pool to hold water. Approximately 11 percent of the foundation floor was previously determined by NTH to contain delaminated concrete or under slab voids. It was also determined that effective construction joints were not incorporated into the original construction and poorly installed water stops that moved during the concrete placement have led to planes of weakness in the concrete.

Further testing of the concrete foundation is recommended to verify the stability and integrity of the existing pool structure prior to finalizing any treatment recommendations. A Ground Penetrating Radar survey has been proposed and tentatively scheduled for March 2, 2011, pending favorable weather conditions. This survey will provide a more accurate reading of any under-slab voids or areas that may require additional repair. In addition to the GPR survey, several core samples should also be collected to verify the concrete ingredients, aggregates, mixture ratios, and structural integrity.

Should the GPR survey and core samples reveal no additional areas that warrant concern, repairs should be undertaken to patch and repair all voids, cracks, and other surface deteriorations in accordance with NTH's previous assessment (see Appendix B).

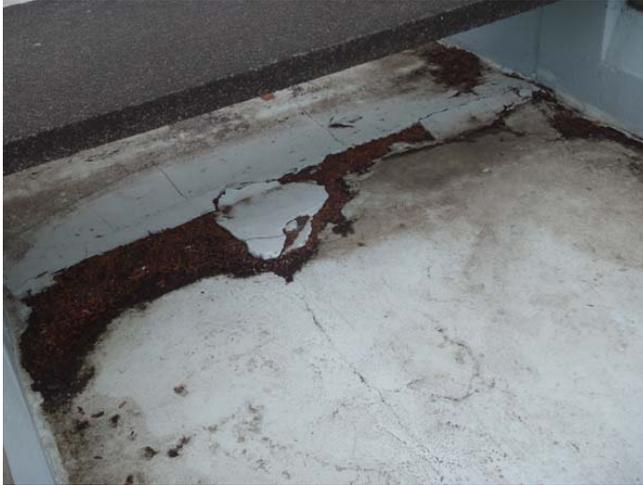
As more water continues to infiltrate the structure and undergo freeze-thaw cycles with the change in seasons, the cracking and pitting of the structure will remain active. The extent of future cracking and spalling cannot be fully determined without additional analysis of the concrete foundation and base beneath the surface. Given the extent of damage which can be ascertained visually, the level of deterioration below the surface could actually exceed that which was initially determined through sound-hammering of the concrete. In all, the extremely poor condition of the reflecting pool requires further invasive investigation prior to moving forward with any treatment recommendation.

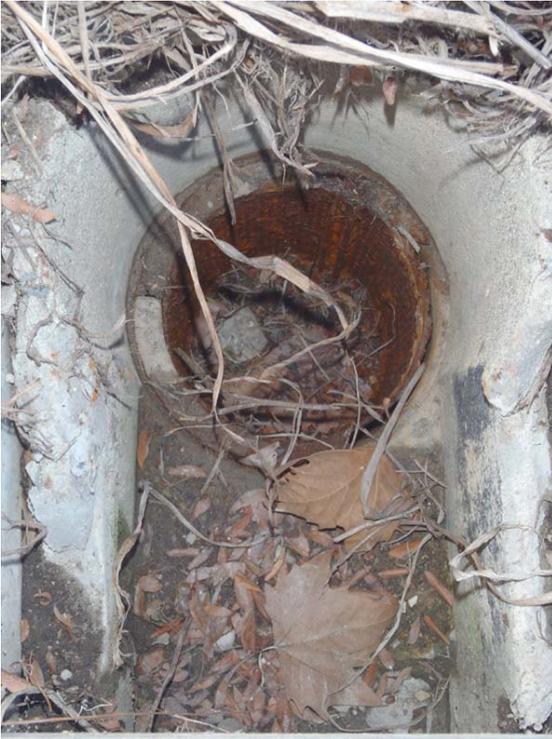
Two main area drains are located beneath bridges #4 and #6. Without existing drawings showing the precise location of the recirculation lines, it is assumed that the main line runs due south from the equipment room beneath the McGregor plaza deck where it enters the court below the foundation slab. The line then branches off east and west just north of the sculpture islands before heading south to each of the two drains. Isolating the branch that leads to the equipment room will help determine if the leak is below the McGregor plaza deck or beneath the concrete foundation of the pool. Given the current, frozen state of the ground, retesting of the main drains should occur following the next thaw cycle.

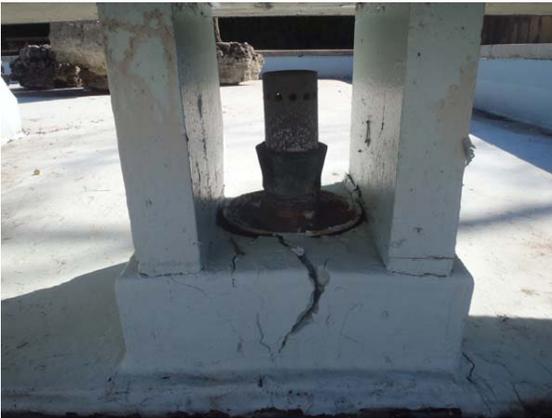
In addition to the two main drains, two overflow drains were also located beneath bridges #3 and #8. These are isolated drains that feed directly into the sewer system and are not integrated with the re-circulating water of the pool. Cracking of the concrete base was observed at both overflow drains.

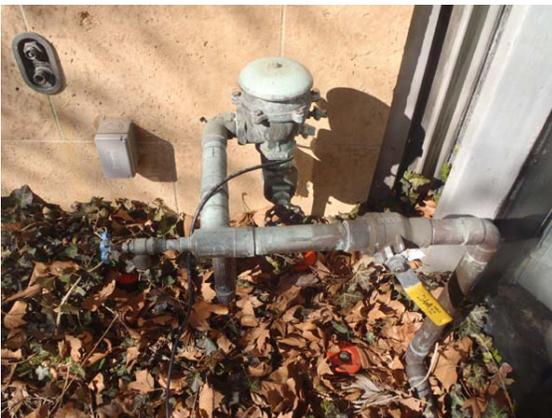
An existing, manual fill connection is located at the northeast corner of the L-shaped court. This connection runs north into the tunnel just below the existing Breezeway and was observed to contain the proper “air gap” required for backflow prevention to the primary water source. A sanitizing system does not currently exist for the pool.

Based on current findings, the existing mechanical (pump and filter) and plumbing components are in poor condition and deficient by today’s standards for maintaining proper recirculation.

Based on the current conditions outlined in Section III of this report, the existing plumbing/recirculation lines and pump are deficient by today's standards and should be replaced in their entirety in order to provide adequate recirculation and sanitization of the pool water. The following modifications are recommended:

- Replace existing feeds and returns utilizing 6" suction and 4" returns; a borderline design would consist of 4" suction and 3" returns.
- Increase the number of skimmers to 14-16 and revise the location of all skimmers to accommodate a prevailing westerly wind.
- Revise locations of returns to be every 20'-25' instead of 36'.
- Provide new filter units.
- Provide new sanitizing system.
- Provide new filtration pump with plumbing that could provide a GPM (gallons per minute) rating of 280 to 360 GPM to offer a turnover rate of the entire volume of water within 6 to 8 hours. The current motor can generate approximately 170 GPM.

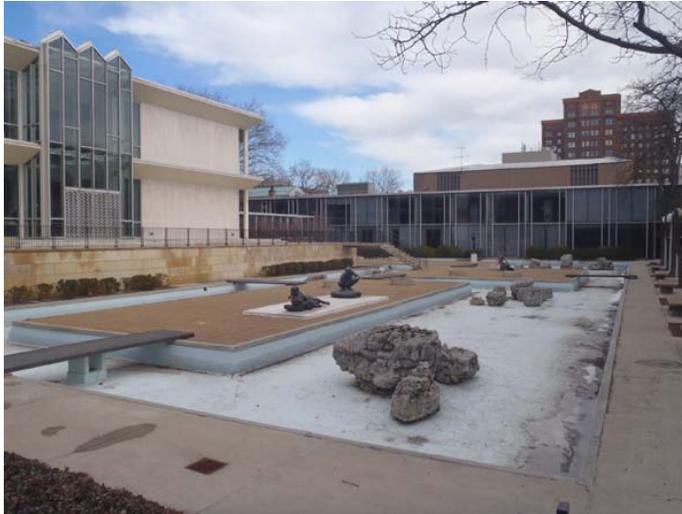
Three rectilinear sculpture islands are located within the reflecting pool, each connected to the terrace and each other by means of a precast bridge finished with exposed black-granite aggregate. The bridges are generally in good condition, with only a few showing signs of slight

bowing across the long spans. Diamond Grey Granite curbs quarried from Minnesota are grout set around the perimeter of the islands and run approximately four feet in length. Cracking was identified in only five of these stones at the time of the survey.

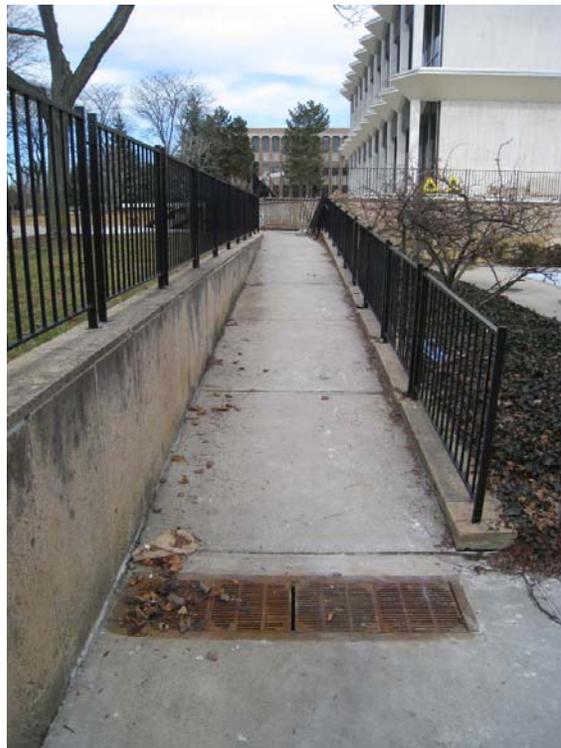
An existing 5' wide, concrete ramp extends from the west side of the perimeter terrace to the finish grade outside the court. The ramp is generally in good condition; however, the ramp does not meet current accessibility requirements for compliance with the American Disabilities Act. Although the slope and width comply with current regulations, the 46' run exceeds the maximum allowable length (30') before requiring an intermediate 5' landing. Handrails are also required on both sides of the ramp; none are provided.

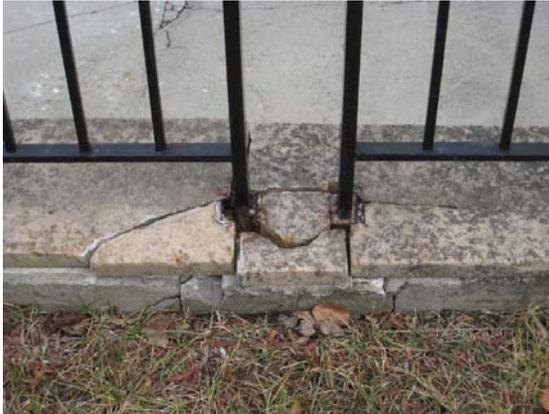
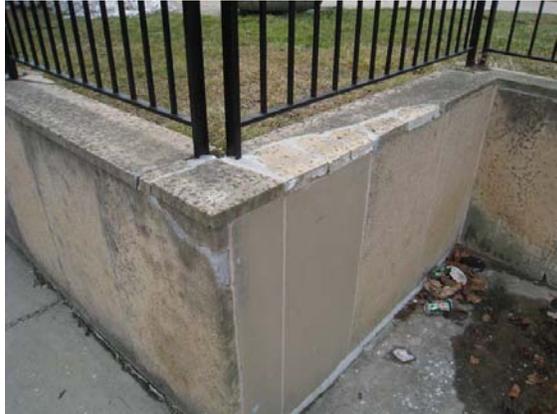
Continuous, metal guardrails extend along both sides of the ramp. These rails are painted black and were observed to be stable. The stone copings beneath the guardrails have considerable damage at each mortar joint where the guardrails are anchored into the retaining wall below. Additionally, several stone panels along the sides of the retaining walls were observed to be cracked and/or missing. One location in particular was observed to be in-filled with painted foam board. Many

of the mortar joints between the Mankato stone have deteriorated and opened. This condition was particularly prevalent near the lower landing of the ramp and southernmost retaining wall next to the Art Building. Isolated locations of displacement and patched stone were also noted along the ramp.
