WAYNE STATE
UNIVERSITY

McGregor Pond Restoration
Detroit, Michigan

SCHEMATIC DESIGN REPORT

March 3, 2011

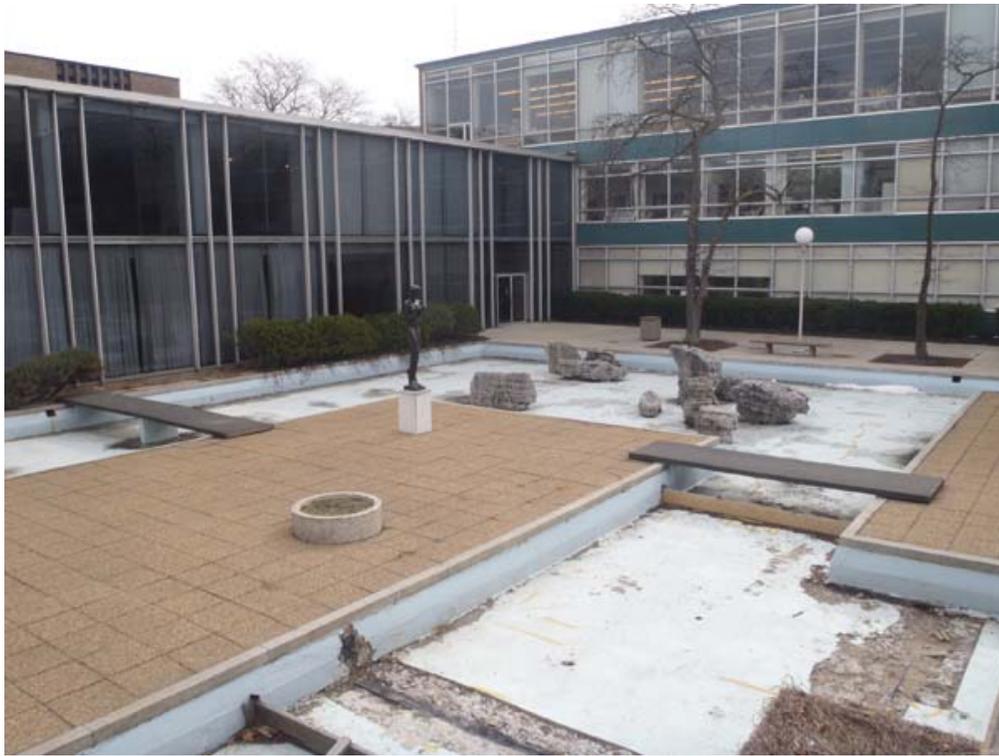
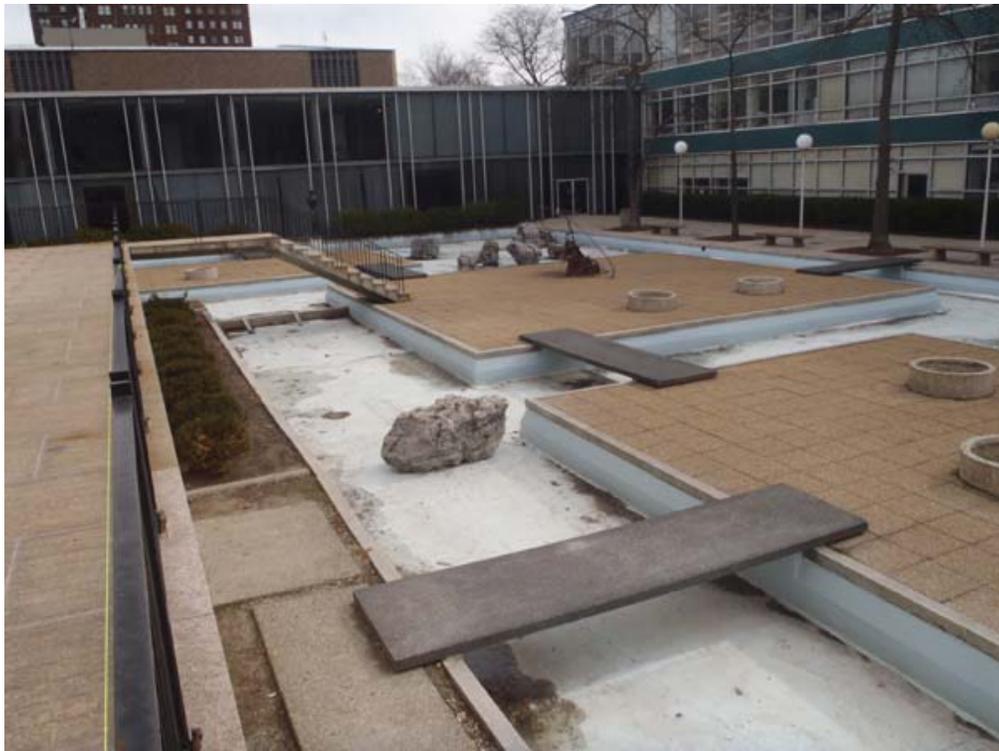
As indicated, the concrete foundation is plagued with severe cracking and spalling, leading to water infiltration within the structure and the inability of the pool to hold water. Approximately 11 percent of the foundation floor was previously determined by NTH to contain delaminated concrete or under slab voids. It was also determined that effective construction joints were not incorporated into the original construction and poorly installed water stops that moved during the concrete placement have led to planes of weakness in the concrete.

As more water continues to infiltrate the structure and undergo freeze-thaw cycles with the change in seasons, the cracking and pitting of the structure will remain active. The extent of future cracking and spalling cannot be fully determined without additional analysis of the concrete foundation and base beneath the surface. Given the extent of damage which can be ascertained visually, the level of deterioration below the surface could actually exceed that which was initially determined through sound-hammering of the concrete. In all, the extremely poor condition of the reflecting pool requires further invasive investigation prior to moving forward with any treatment recommendation.

In addition to the significant decay of the structural surface, the original matte-black finish used on the reflecting pool walls and foundation floor has been repainted light blue. The aquatic planters once recessed below the water level have also been removed, leaving only the original limestone boulders set within the reflecting pool area.

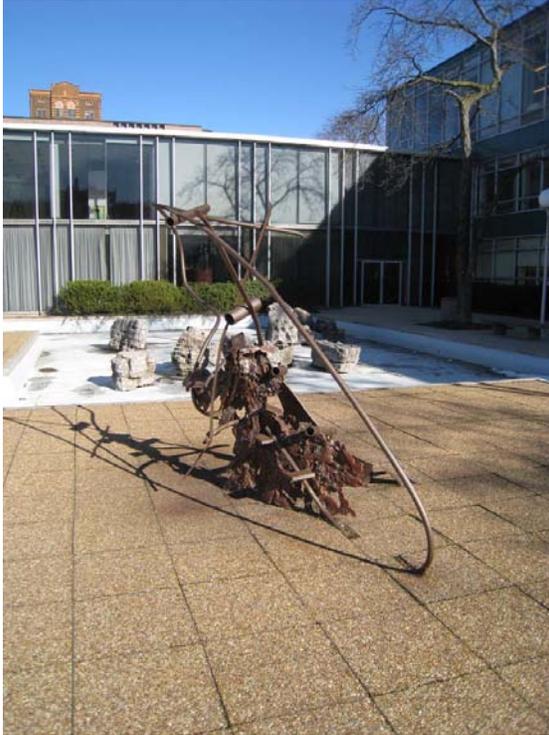
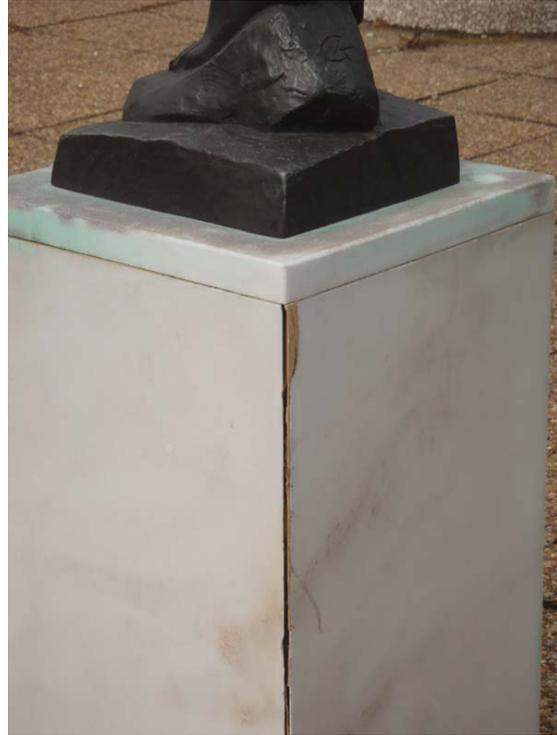
Four bronze sculptures currently sit on the islands which have been added over the decades since the sculpture court was originally completed. Giacomo Manzu's *Nymph and Faun* sit atop a long, rectilinear, white marble base that rises approximately three inches above the paving on Island #1. Georg Kolbe's *Assunta* is located at the southern end of Island #3 and sits atop a taller, square marble pedestal. Both marble bases exhibit significant deterioration at the corner joints with some staining from runoff of the bronze patina. A contemporary metal sculpture by Michael Todd has also been added to the center island.
